Use Attainability Analysis
for
Water Body Identification # 3009
Cache River Ditch

Conducted by:
Environmental Resources Coalition

Stream Description – WB ID: 3009 – Cache River Ditch

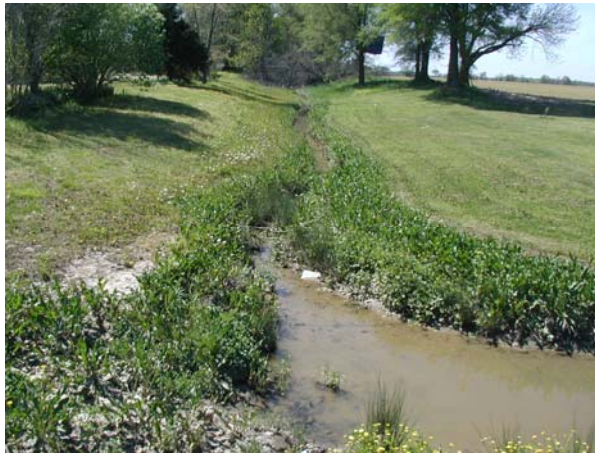
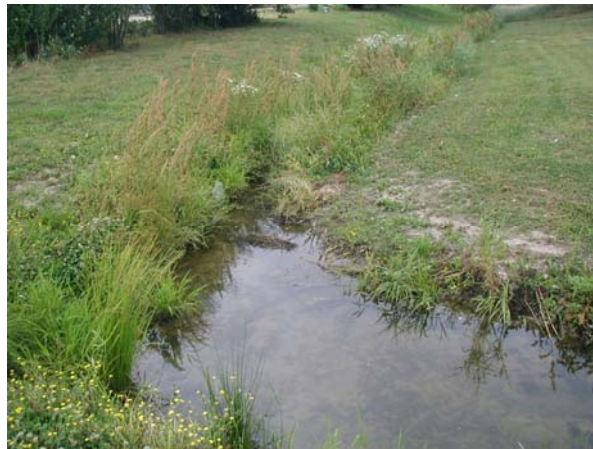
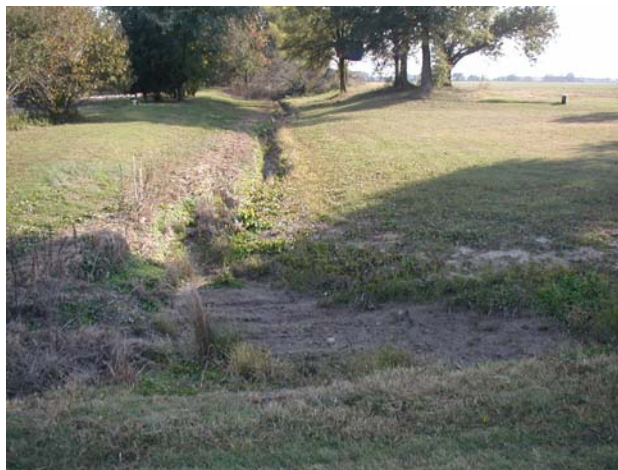
Downstream Views

The upstream view is outside of the classified reach

NOTES: Site # 1 is the uppermost assessment site on the Cache River Ditch

10/26/05 – stream was dry – no water present

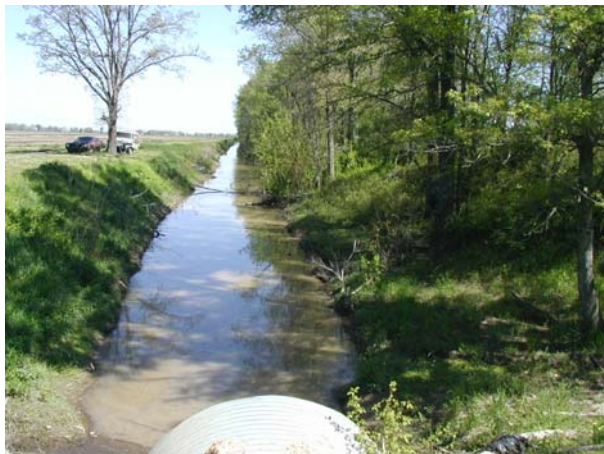
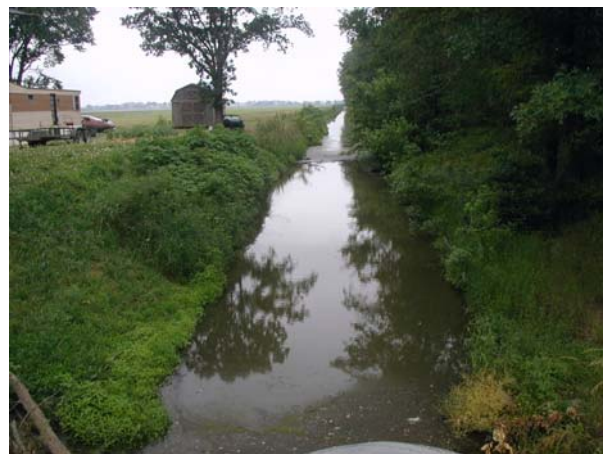
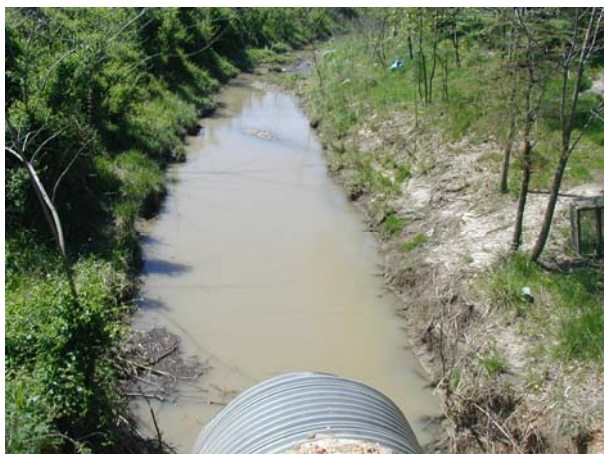
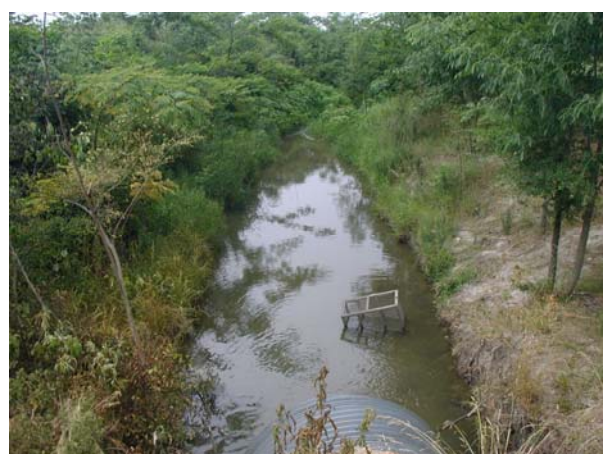
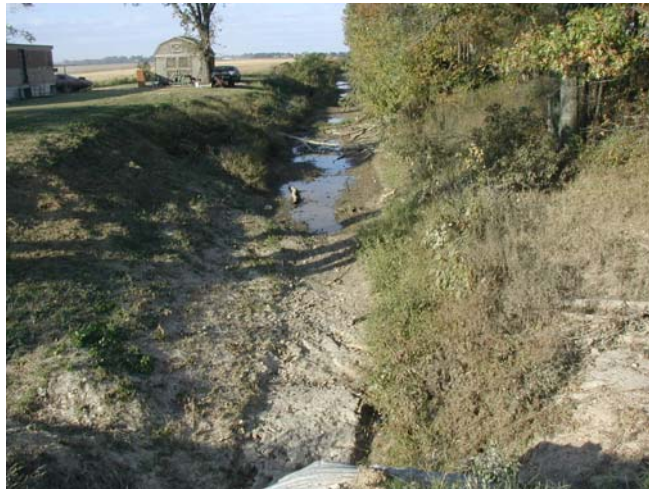
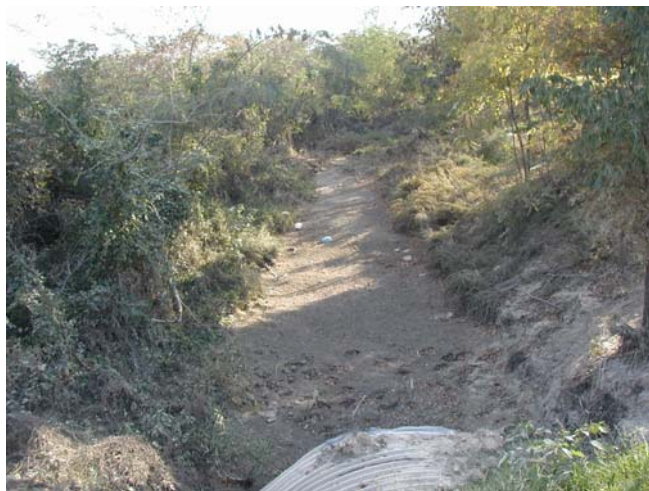
Site # 2 - County Road 214

04/15/05 – Adjacent landowner interviewed said stream depth will quickly get shallower over time due to recent culvert replacement

06/02/05 – Stream depth is substantially increased due to local irrigation discharge.

10/26/2005 - The upstream location of this site was mostly dry with only shallow pockets of standing water present.

Site #2: Site # 2 of the Cache River Ditch is located on County Road 214 and has steep banks that are approximately 60 percent brush covered. Nearby homeowner was interviewed and stated that the culvert for County Road 214 had recently been replaced and that the county road crew told him that the stream would more than likely stream quickly lose depth at this location over time. However, on the June 2nd visit, the depth was much greater than the first visit due to local crop irrigation.

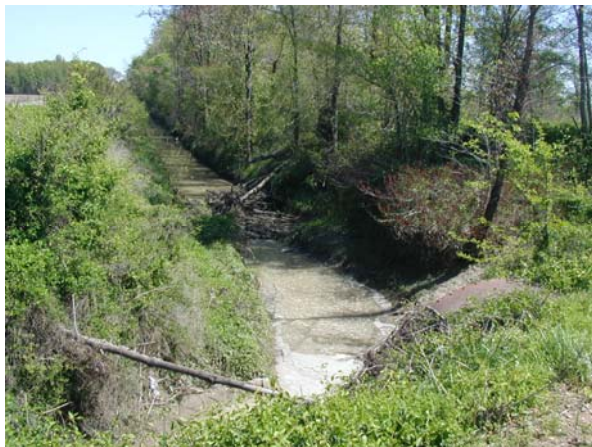
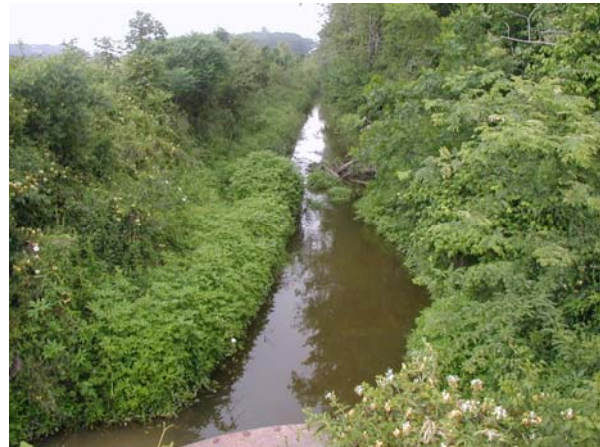
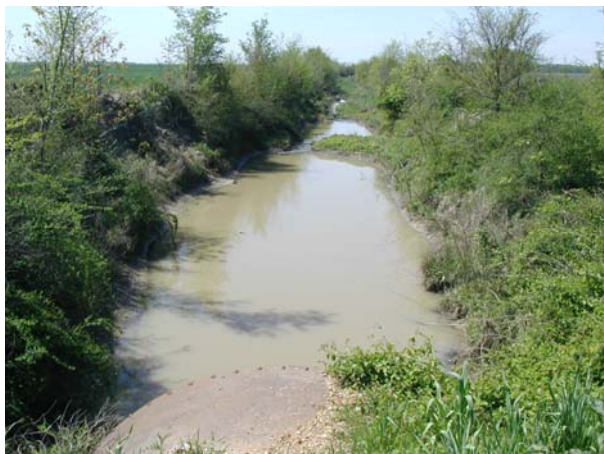
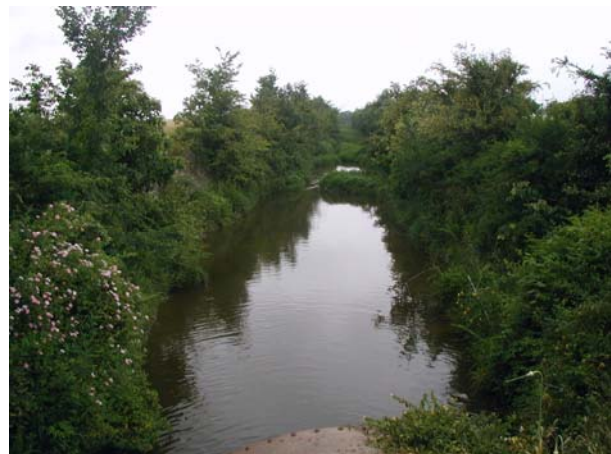
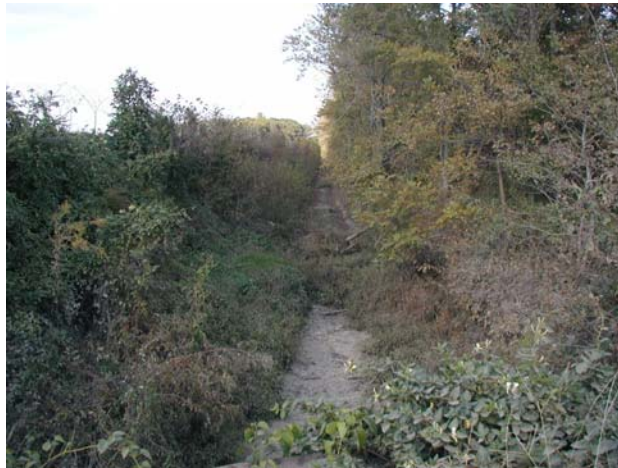
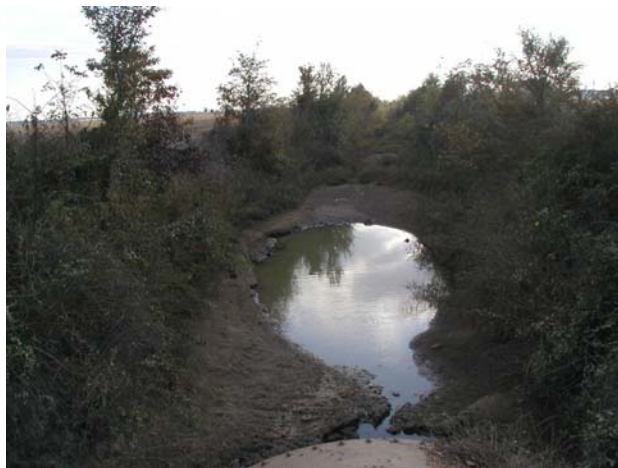
Site # 3 - County Road 220

10/26/05 – Stream is dry – No water present except for a small hole downstream where a field pipe drains into the stream. The standing water present was only ankle deep and no cross-section measurements taken.

Site #3: Site #3 of the Cache River Ditch is located on County Road 220. Farm fields surround the area. The vertical banks are approximately 12 feet high and are brush covered. Trash, including various appliances and tires, are scattered throughout the site.

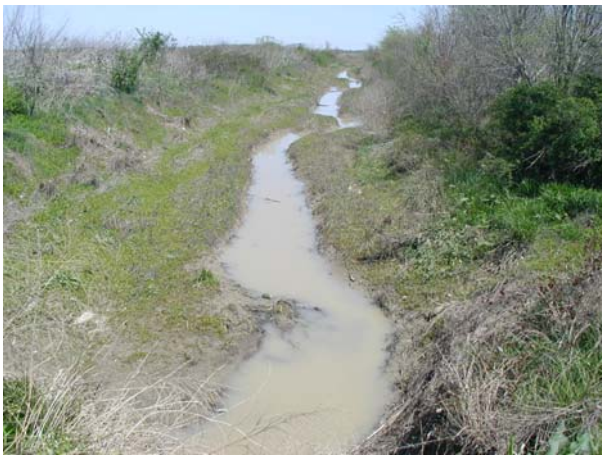
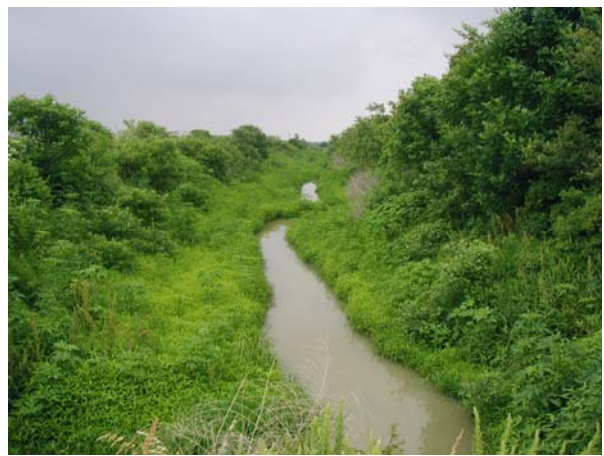
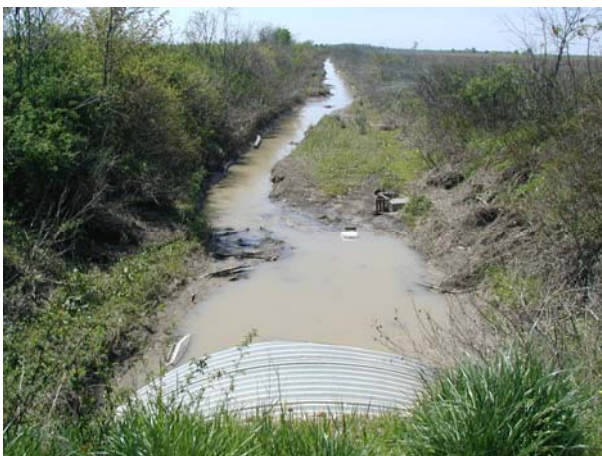
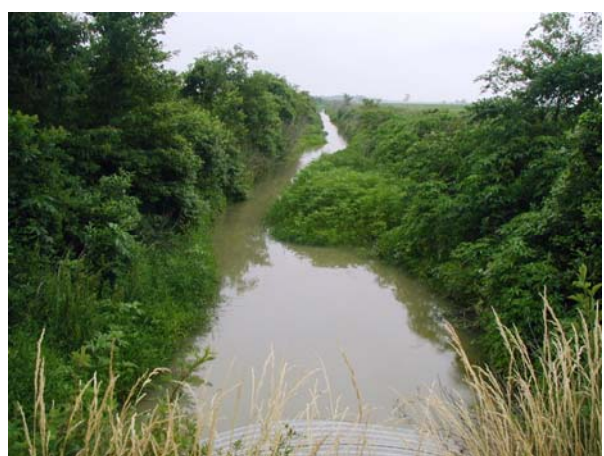
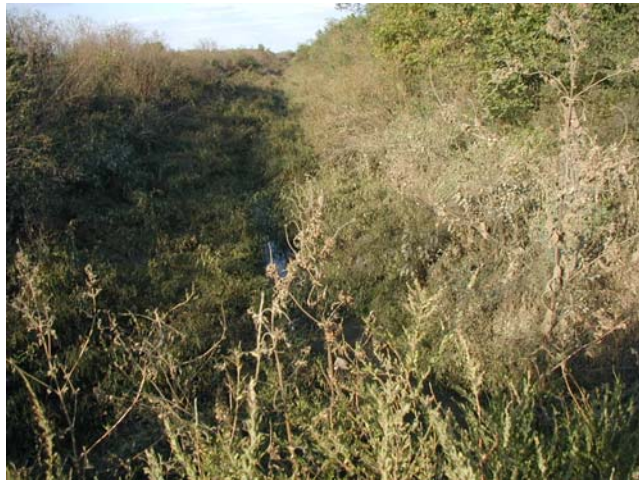
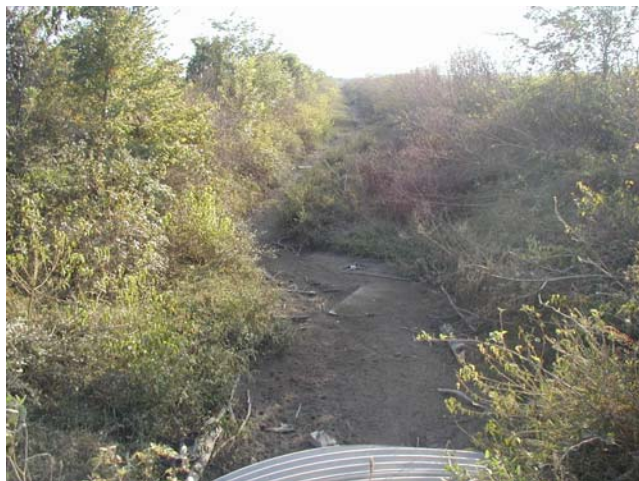
Site # 4 - County Road 236

Site #4: Site #4 of the Cache River Ditch is located on County Road 236. Farm fields surround the area, and several drainage pipes from these fields discharge into the ditch. The steep banks are 12-16 feet high and brush covered, making the site very difficult to access. Appliances, tires, broken beer bottles, car parts, and barbeque grills are some of the various items that have been dumped at this location. During the visit on April 15th, two older gentlemen on horseback stopped. Although no formal interview was conducted, they commented that "No one has been in these ditches for over 50 years."

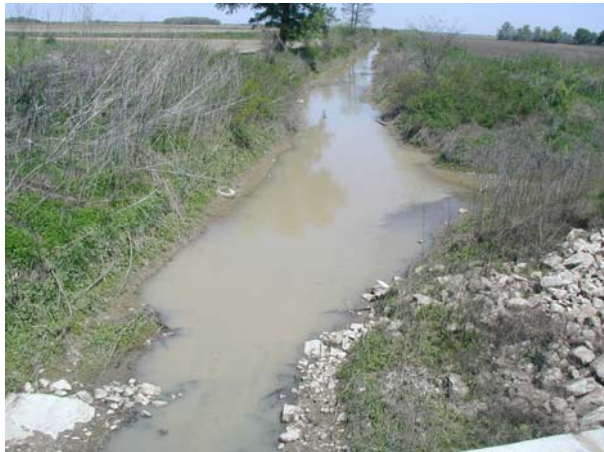
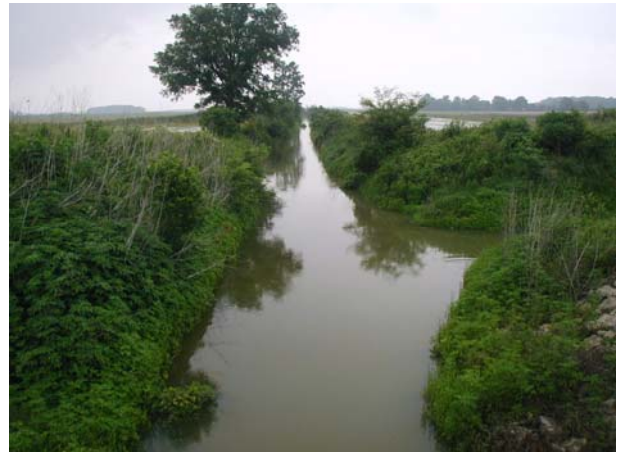
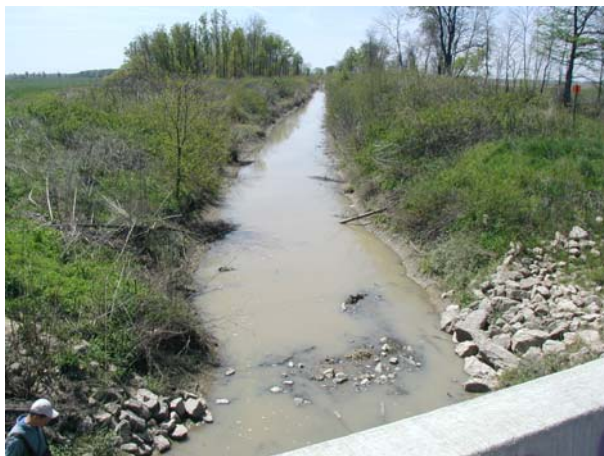
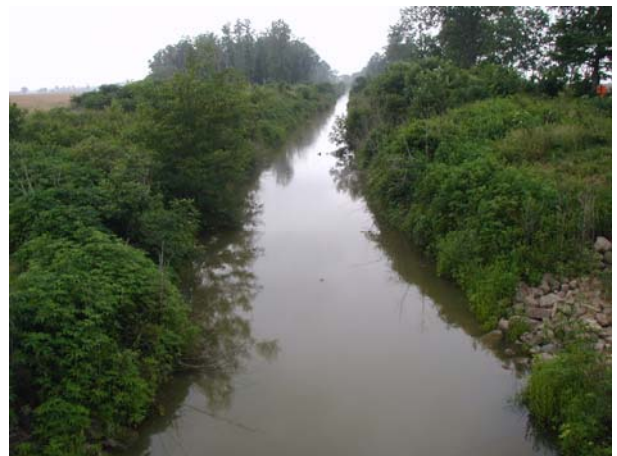
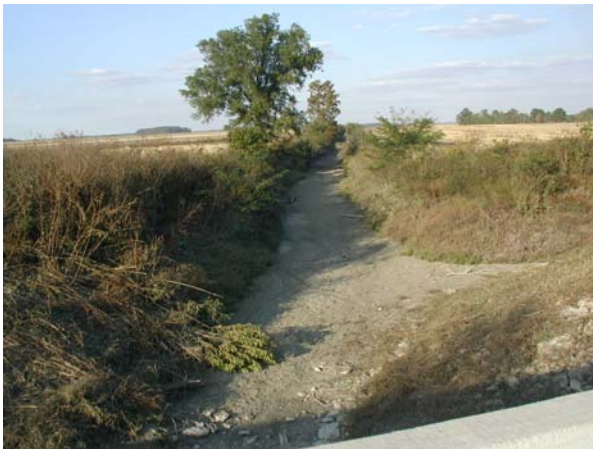
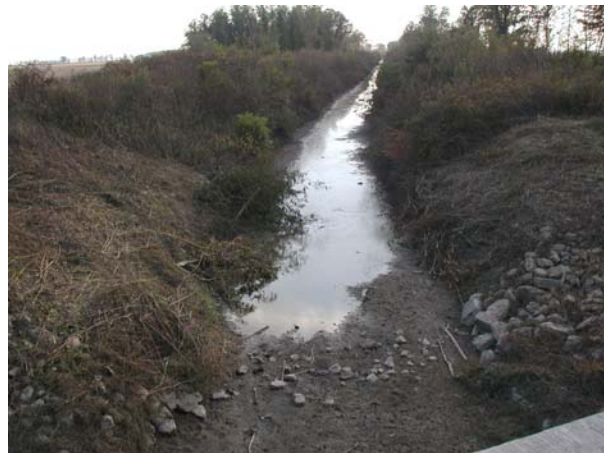
Site # 5 - Highway N (south)

06/02/2005 – Grass has been mowed since last visit around the bridge to the stream bank.

A discrete measurement for the downstream assessment location on 06/02/2005 met the 0.5 meter average depth. However, this was during a period of high irrigation related field drainage discharge, a hydrologic modification, which has a very substantial and transient affect on the stream. The overall average depth of this assessment location is a 24.1 centimeters, which is much more characteristic of this stream at this site.

Site #5: Site #5 of the Cache River Ditch is located on Highway N south. Farm fields surround the area. The banks were approximately 12-16 feet high and covered in brush. Along with the steep banks, stabilization rocks near the bridge made accessing the stream extremely difficult. The stream had a large amount of trash at the site which is likely due to traffic on Highway N.

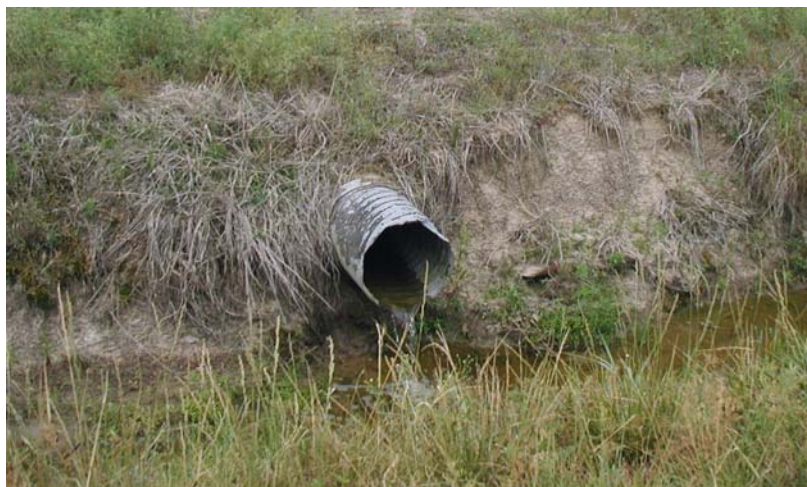
An Example of Irrigation Related Field Drainage Discharge
